# Effect of Weir on Honeoye Lake Level

Jack Starke

October 1, 2014

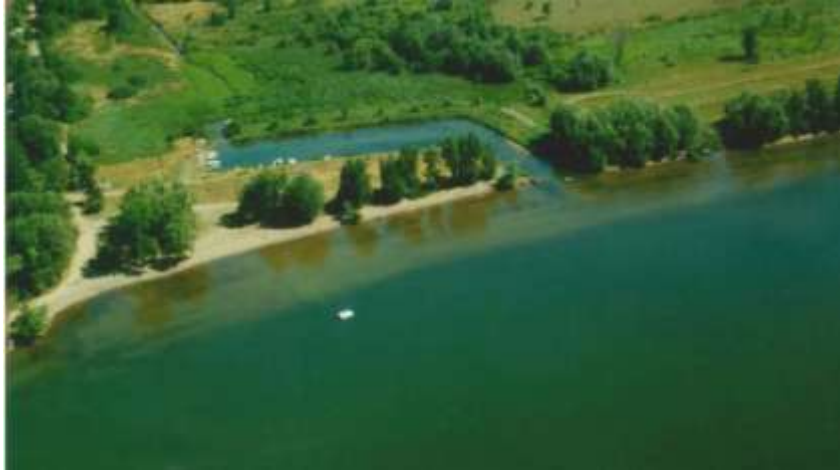
**Weir in 1950s**

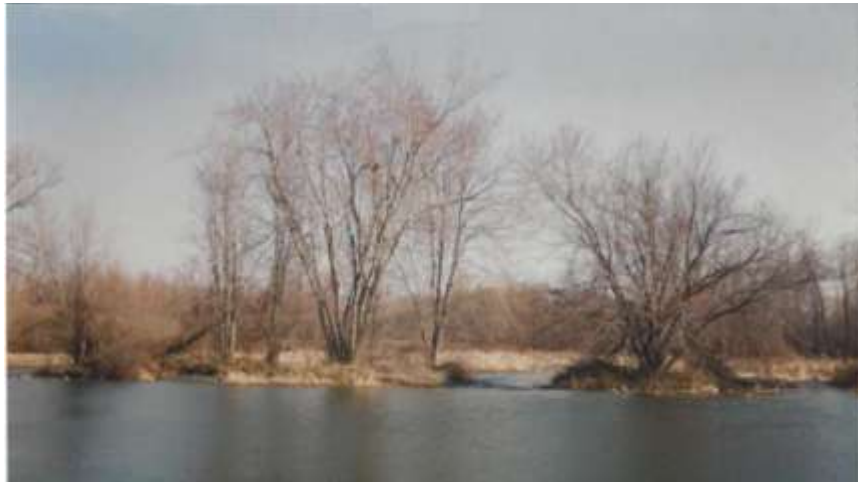
**Weir in 1998**

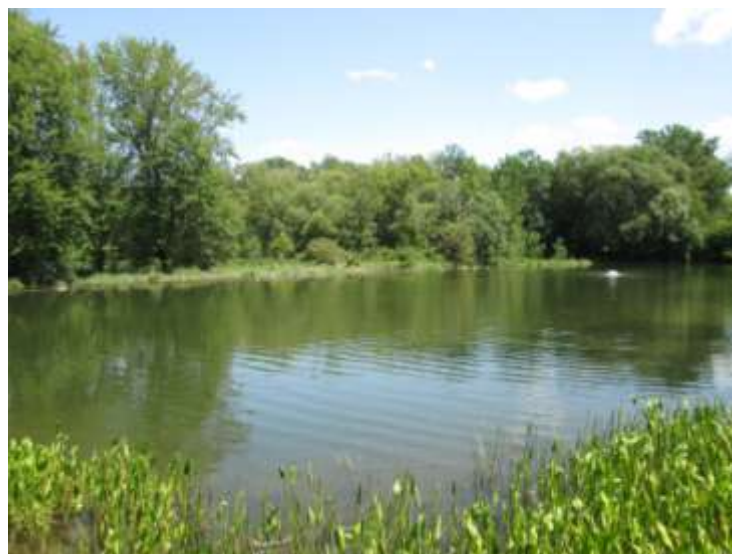
The new weir completed in 1999, although not radically different from the older earthen weir, does maintain the lake at more constant level.

**Weir in 2014- after new weir installed in 1999**

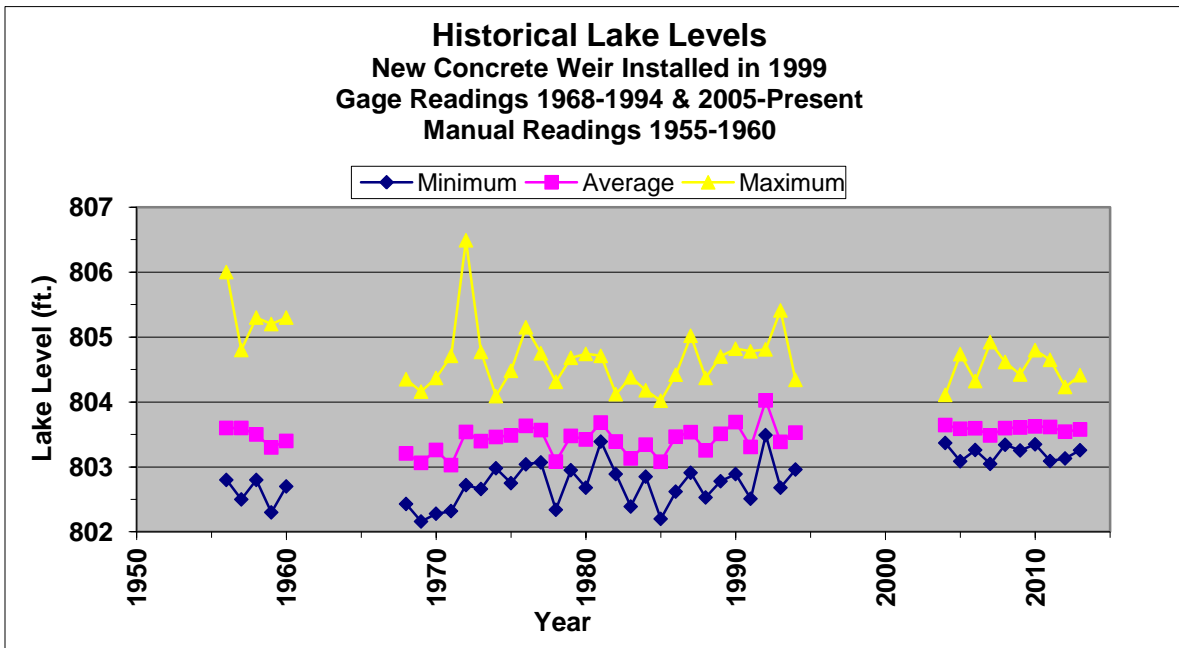
Figure 3

While pictures give a subjective impression of the weir, it is more instructive to examine the resulting lake level over the 60+ year time interval (Figure 3). Lake level monitoring varied in its frequency during this period; with volunteers from 1955-1960, USGS 1968-1994, and Telog monitoring equipment 2005-present. Maximum levels are primarily caused by the severity of storm events, and the lake generally returns to normal within a short period of time. Hence, maximums are not a good measure of the weir's effectiveness at maintaining a constant lake level. Since there are no recorded lake levels prior to 1955 when the original earthen weir was installed, it is not possible to access its effect. The average level shows that after the changes to the weir in 1998 there are more uniform levels from year to year, and the lake level is closer to the target level. The minimum lake level generally occurs during the summer months and is about 5 inches higher with the new weir, since the weir is more uniform in height across its width and does not have low points that allow draining below the target lake level. This results in keeping the lake level closer to its long term average of 803.5. **Hence both the new and old weirs have done an excellent job, with the new weir somewhat more effective at controlling a more uniform lake level.**

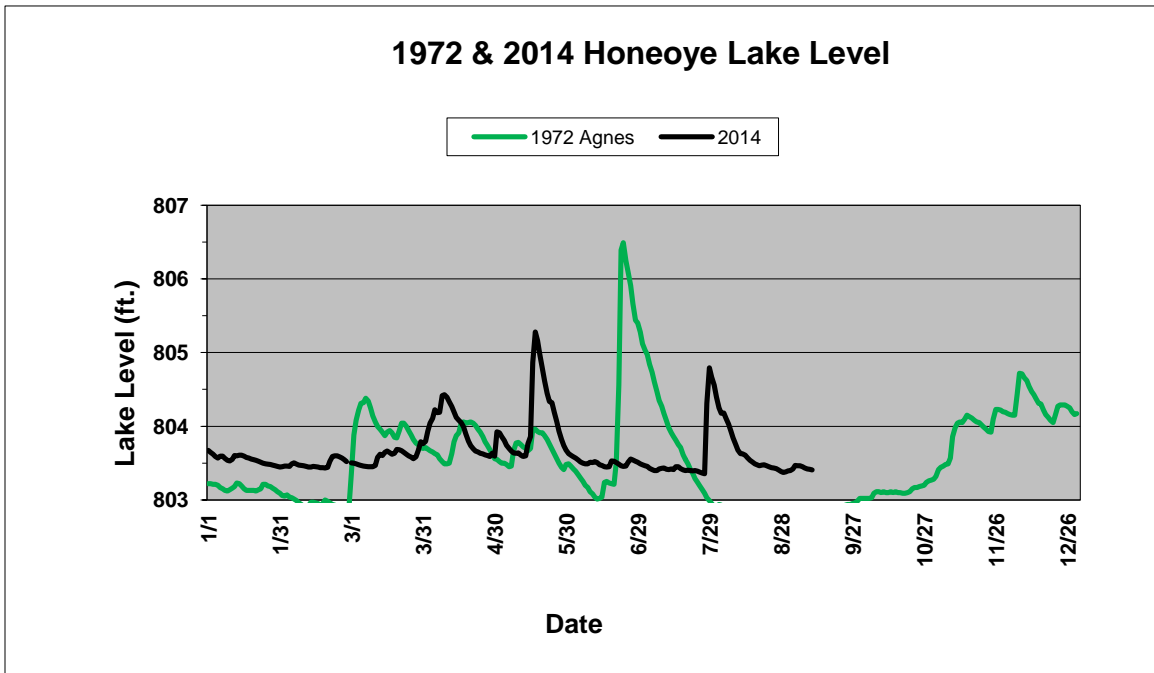
Figure 4 shows the lake level and precipitation for 2014, which clearly shows two major increases in the lake level due to severe storms this summer. On May 16 2.5 inches fell and on July 28 6.3 inches. Since 1992 the

next highest daily precipitation was 3.7 inches in 1994 and 2.6 inches in 2005, making these very significant storms. Both of these storm events resulted in highest recorded lake levels (805.3 & 805.9) except for 1972 during Hurricane Agnes (806.5) and 1993 (805.4). The lake level in 1972 during Agnes is also included in Figure 4 as a comparison to this year and clearly shows it to be a significantly more severe event both in terms of maximum lake level and duration above the target lake level. There was also significant shorefront damage in 1972.

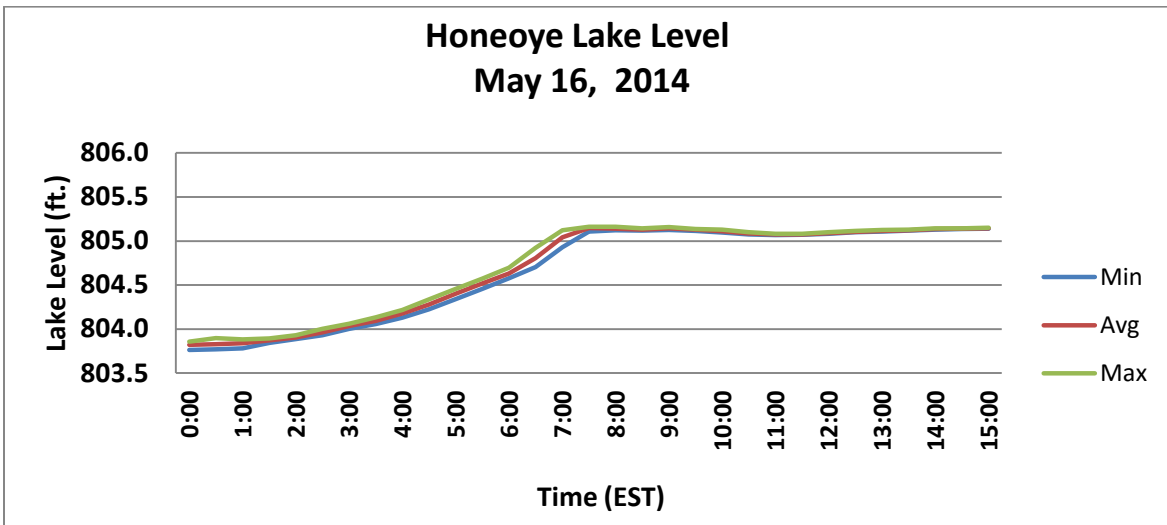
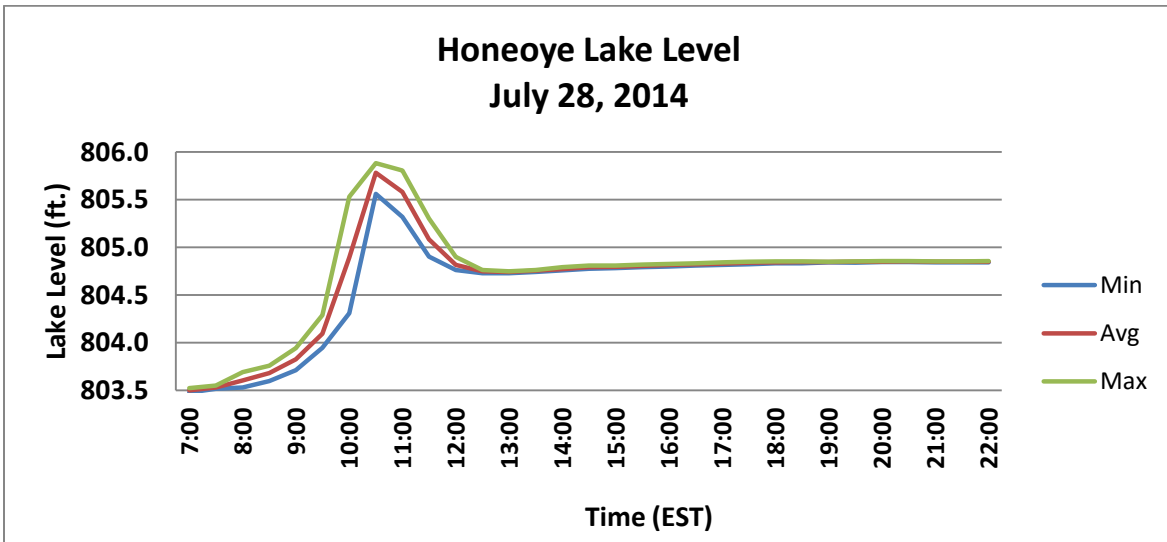
The two storms this summer were quite different in the rate of rise and fall of lake level as shown in Figures 5 & 6, which are both plotted using the same scale over a 15 day period. In the May storm the lake level rose at a rate of 0.18 ft/hr during its initial stage whereas for the July storm it was 0.96 ft/hr, which is larger by over a factor of five. The reason that the maximum lake level reported in Figure 4 is less than in Figure 6 is that in Figure 4 the lake level is the daily average. This rapid rise in the July storm is further discussed in a later section on the effect of Mill Creek.

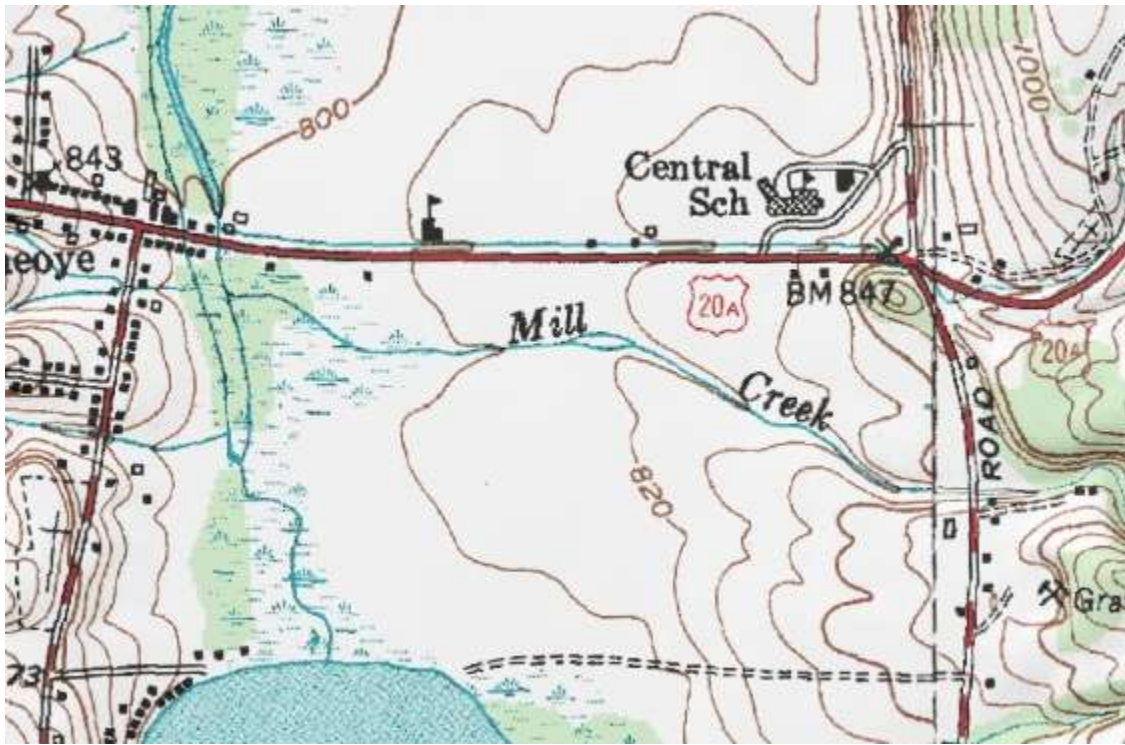
Figure 7

creek level rose dramatically to accommodate the large volume of water. When this water flowed further west into lower flatter terrain (Figure 7) it spread out and flooded the area around the Mill Creek Café, Gazebo, and Christman insurance agency. Flooding in the western portion around Honeoye Central School was probably from the water coming down the hill on 20A. Hence, the flooding of Honeoye was primarily due to the 6.3 inches of precipitation over a few hours and the topography around Mill Creek and the region west of town. **The weir and lake level did not contribute to the flooding.**
