# Honeoye Lake Watershed Task Force Newsletter

# 2019 State of the Lake

# Mill Creek Habitat Restoration & Bank Stabilization Project

## Honeoye Lake Shoreline Stabilization at Sandy Bottom Park

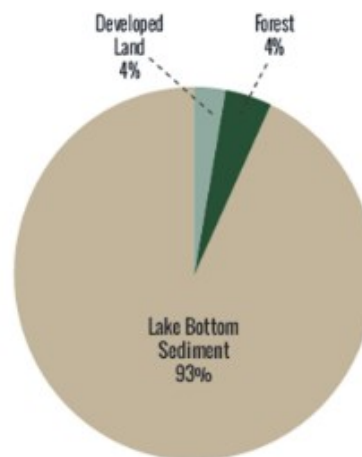
Honeoye Lake  
Phosphorus Loading

These charts show the percentages of different land uses within the lake watershed and an estimate of the amount of nutrients entering the lake from nonpoint sources.

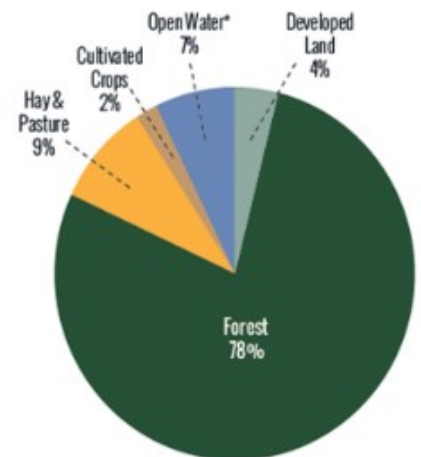
Honeoye Lake  
Land Use

\*Open water represents all surface water (lake, rivers, streams) in the watershed.

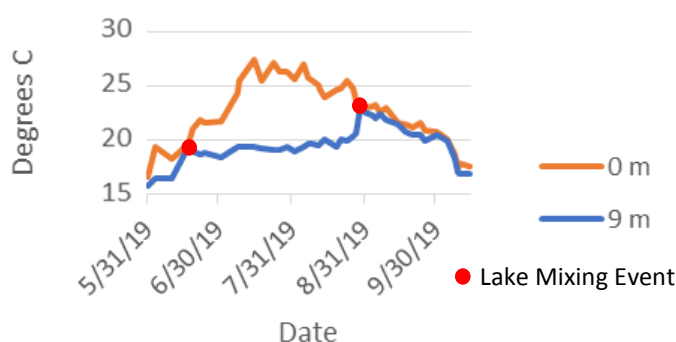
## 2019 Water Temperature

The first two graphs above show 2019 water temperature (°C) and dissolved oxygen (mg/L DO) trends. The third graph to the left shows the accumulation of total phosphorus (TP) near the lake bottom in late July reaching a very high level of 410 µg/L (the blue line) and only 16 µg/L (the orange line) near the surface. Anything greater than 20 µg/L at the lake surface is considered eutrophic. The lake experienced some wind generated internal waves in August reflected by the rising blue bottom temperature line and declining bottom blue TP line while the orange surface TP line steadily increased. The internal waves caused some amount of water exchange between the surface and bottom water. On August 27<sup>th</sup> we had a south wind exceeding 20 MPH which led to a complete lake mixing event.

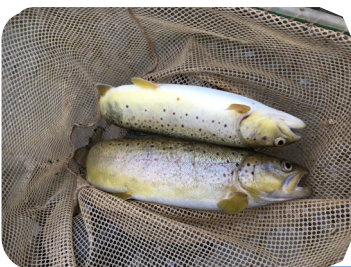
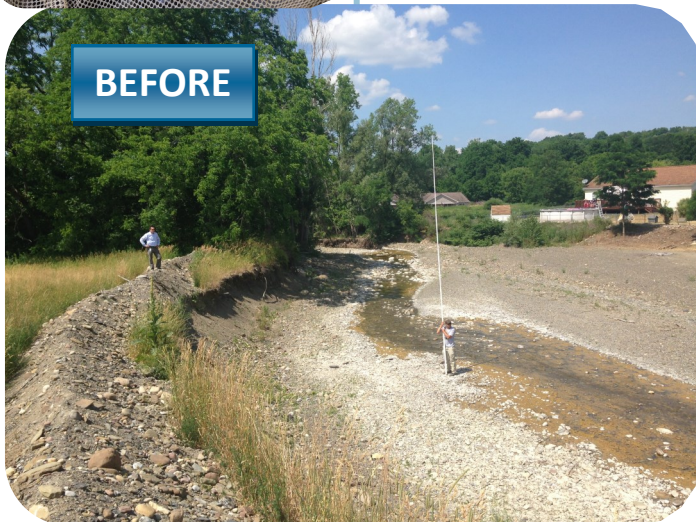
**BEFORE**

The Town of Richmond partnered with the U.S. Fish and Wildlife Service and Ontario County Soil & Water Conservation District to implement a stream restoration project along Mill Creek within Sandy Bottom Park. This restoration project will significantly reduce sediment inputs, improve aquatic functions, and reduce the potential threats to private residential homes and public infrastructure. By using nature based design structures like toewood and stream rock structure, this project stabilized the eroding banks while providing improved fish habitat. The goals of this stream restoration project were to enhance stream habitat, reduce concentrations of sediment, detain and slow runoff, and provide stable conveyance of flows through the stream channel. Prior to the construction, the NYS Department of Environmental Conservation, USFWS, and Ontario County SWCD spent a morning electroshocking this section of Mill Creek to evaluate the current fish population. They will survey this area again in 2020 to evaluate any population changes. Ontario County Highway Department provided the final stabilization by hydroseeding the disturbed areas. Be sure to check this out the next time you are at Sandy Bottom Park. It is accessible from the East Lake Road parking lot.

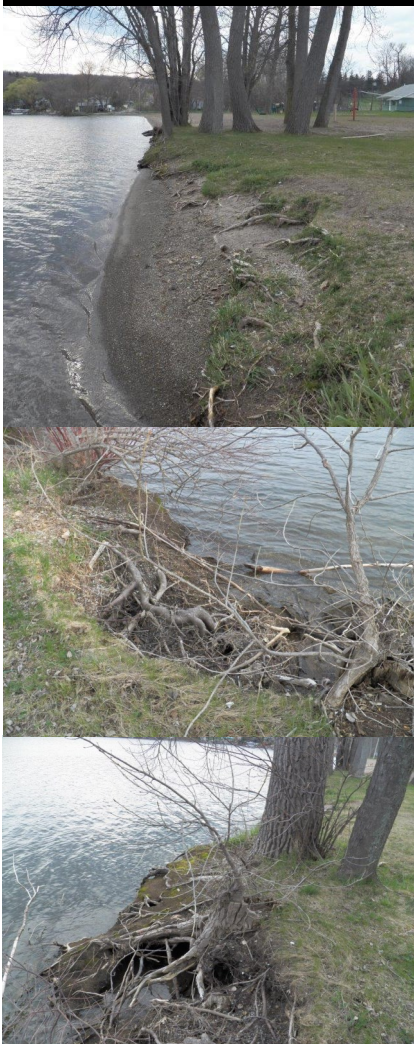
**Before Photographs:**

With funding from the New York State Department of Environmental Conservation Water Quality Improvement Project Grant Program, Ontario County Soil & Water Conservation District and the Town of Richmond installed a natural shoreline stabilization project using coir wrapped soil lifts that incorporate native plant materials. The rock placed in front of the project is necessary to reduce wave energy and ice scour seen at the north end of Honeoye Lake. Existing trees and shrubs were kept in place to keep the shoreline protected and over three dozen additional plantings as well as live stakes were added to promote deep rooted vegetation to further stabilize the shoreline. The NYS DEC promotes the use of natural materials to stabilize shorelines rather than hardened structures such as retaining walls and gabion baskets. A naturally vegetated shoreline helps reduce erosion, filters excess nutrients from entering the lake and provides habitat for fish and wildlife. Ontario County SWCD was able to obtain funding through the NYS Sea Grant to pay for the engineering and design work for this project. This stabilization project can be seen in Sandy Bottom Park, adjacent to the public swimming area.

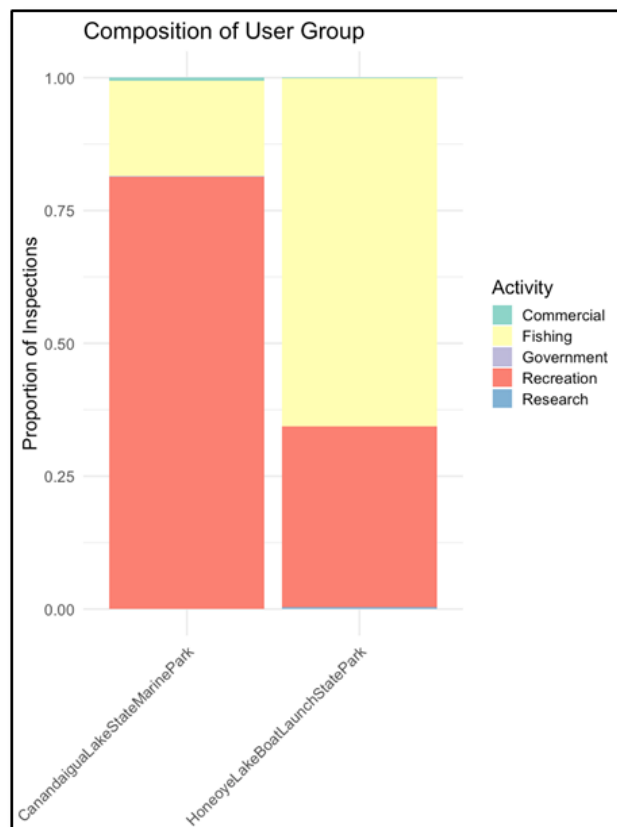
**Figure 1.** Composition of user groups at comparable boat launches in the Finger Lakes, 2019

This figure displays differences in user group proportions between Honeoye Lake State Marine Park, and another State Marine Park on Canandaigua Lake. While activities like commercial and research are consistently low or non-existent for each launch, the proportion of recreation and fishing vary greatly.

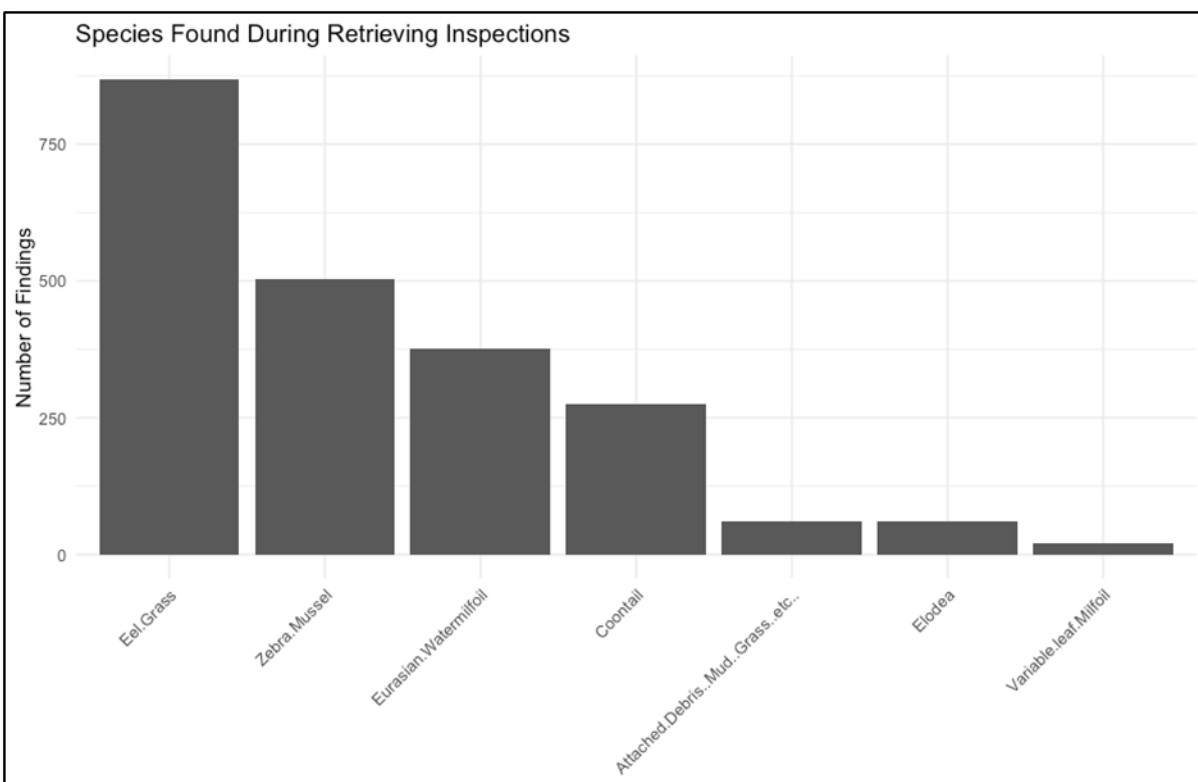
**Figure 2.** Species found during inspection of watercraft launching and retrieving at Honeoye Lake State Marine Park. This figure gives an overview of the different aquatic species found upon exit and entry from the Honeoye Lake. While the native eelgrass dominates the species found during inspections, invasive species like Eurasian watermilfoil and zebra mussels are still frequently found during these inspections.
